# Refurbishment Asbestos Report

Mansion House, Thorpe Hall House, Thorpe Road, Longthorpe, Peterborough, PE3 6LW  
– Prepared for Sue Ryder Care

Mansion House, Thorpe Hall House, Thorpe Road, Longthorpe, Peterborough, PE3 6LW  
ADSCS 74 Revision 8 Refurbishment Asbestos Report

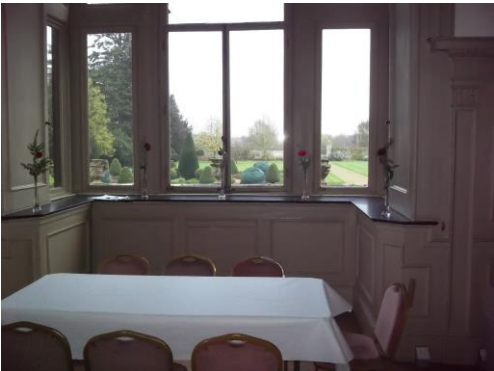
Non Asbestos Containing Material (Non ACM) Register 1		
Status/Sample Number:	13257/S001

Location:	GF6	
Product Type:	Window sill	
Also present in:	-	
Plan Identification symbol:	S1	
Analysis Result: Asbestos Not Detected
