## Refurbishment Asbestos Survey Report

**Thorpe Hall Lodge West Wing, Thorpe Road, Longthorpe,  
Peterborough, PE3 6LW**

**Reference 9679**

**Survey Date 27<sup>th</sup> September 2012**

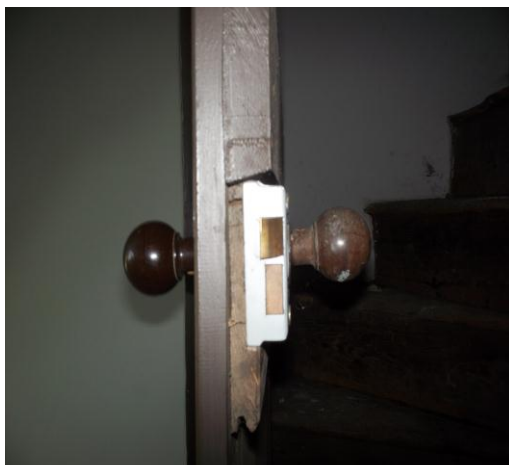
<b>Location:</b> 2F3

<b>Extent:</b> 2no.
<b>Material:</b>  Bakelite door handles		<b>Condition:</b>  Good
<b>Asbestos Type:</b>  Crocidolite		<b>Plan Identification Symbol:</b>  <div style="text-align: center;">

Material Assessment – Mean Scores			
Parameter			
Product Type (1-3)	Damage (0-3)	Surface Treatment (0-3)	Asbestos Type (1-3)
1	0	0	3

Management and Control Recommendations			
Recommendations	Duration		
<b>Remove</b>	<b>Prior to any indirect or direct disturbance</b>

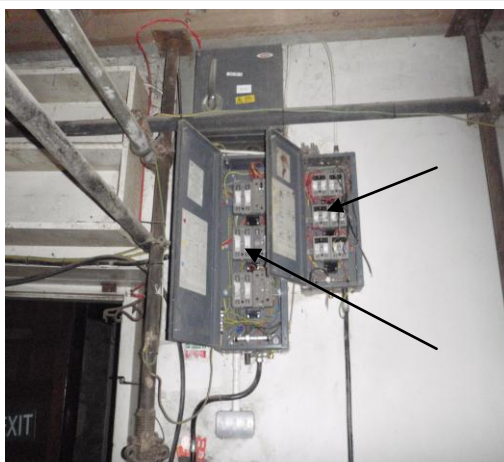
Material:  
Flashguards to  
fusebox

Asbestos Type:  
Crocidolite

Extent: 15no.

Parameter			
Product Type (1-3)	Damage (0-3)	Surface Treatment (0-3)	Asbestos Type (1-3)
2	0	2	3

Recommendations	Duration
<b>Remove</b>	<b>Prior to any indirect or direct disturbance</b>

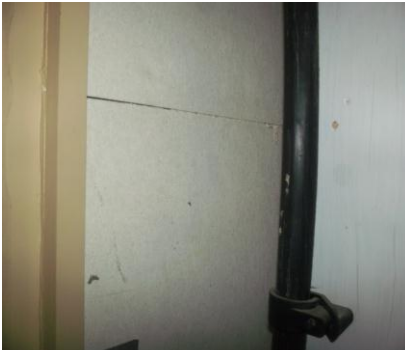
Status/Sample Number:  9679/S002

Location:  1F4
Product Type: Insulation board to left wall of cupboard		Plan Identification symbol:

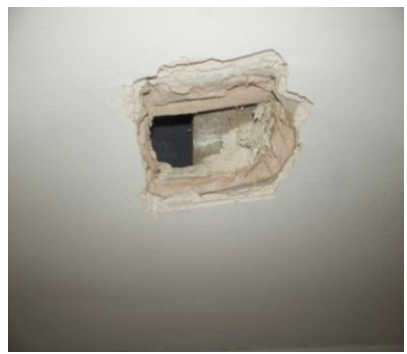
Status/Sample Number:  9679/S006

Location:  GF9
Product Type:  Inner layer of Insulation board to beam		Plan Identification symbol:

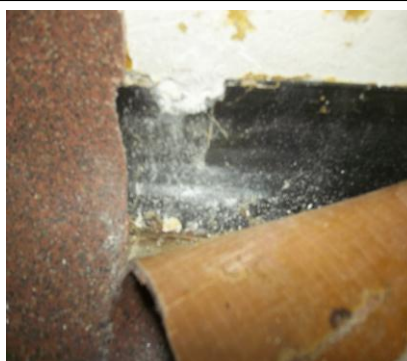
Status/Sample Number:  9679/S007

Location:  GF9
Product Type:  Bitumen kickstrip below lino		Plan Identification symbol:

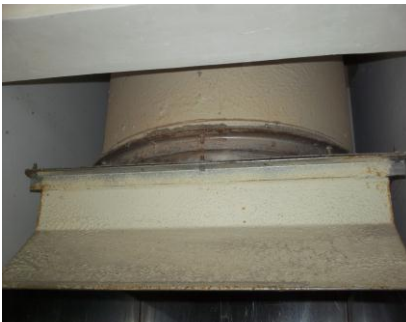
Status/Sample Number:  9679/S008

Location:  GF9
Product Type:  Textured coating to laundry chute		Plan Identification symbol:

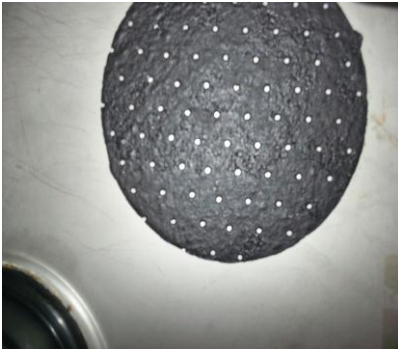
Status/Sample Number:  9679/S009

Location:  GF9
Product Type:  Bitumen sink pad		Plan Identification symbol:

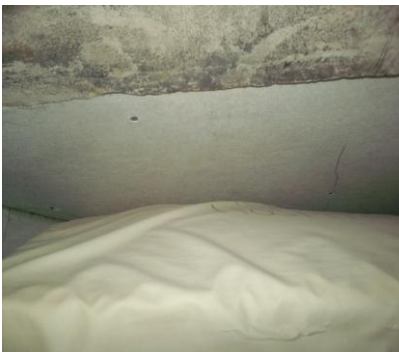
Status/Sample Number:  9679/S011

Location:  1F18
Product Type:  Insulation board to fireplace		Plan Identification symbol:

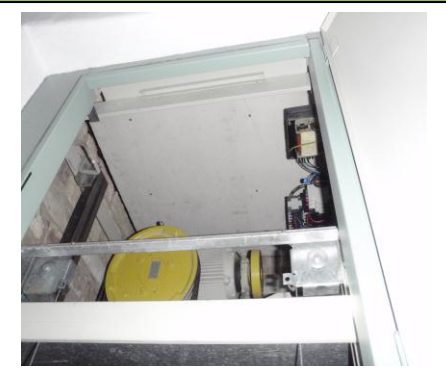
Status/Sample Number:  9679/S012

Location:  Dumb waiter adjacent to 1F15
Product Type:  Insulation board to ceiling		Plan Identification symbol:

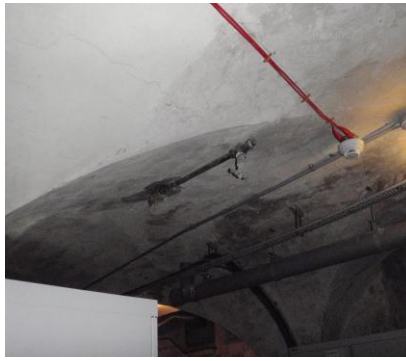
Status/Sample Number:  9679/S015

Location:  Basement
Product Type:  Pipe insulation		Plan Identification symbol:   
Also present in:		
Analysis Result: Asbestos Not Detected

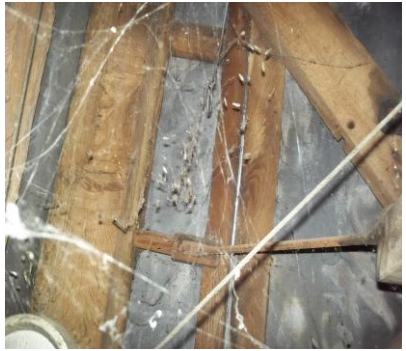
Status/Sample Number:  9679/S017

Location:  Bell tower
Product Type:  Bell tower wall		Plan Identification symbol:

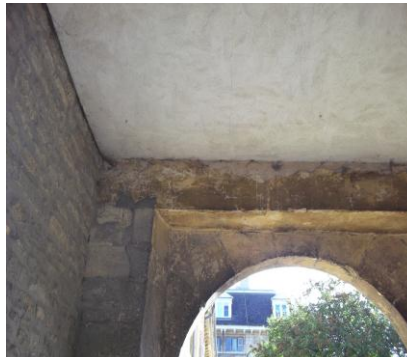
Status/Sample Number:  9679/S018

Location:  External archway
Product Type:  Textured coating to ceiling		Plan Identification symbol:
