HISTORIC BUILDING APPRAISAL

THORPE HALL

February 2011

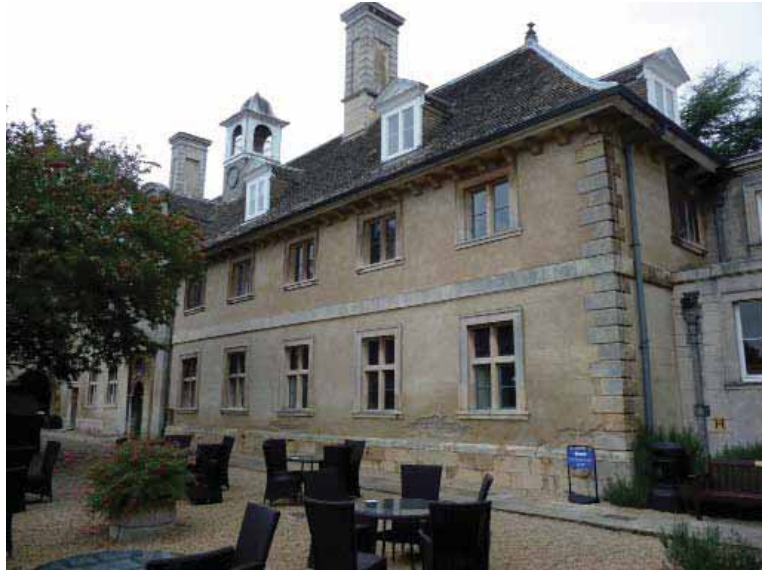
South elevation of service wing

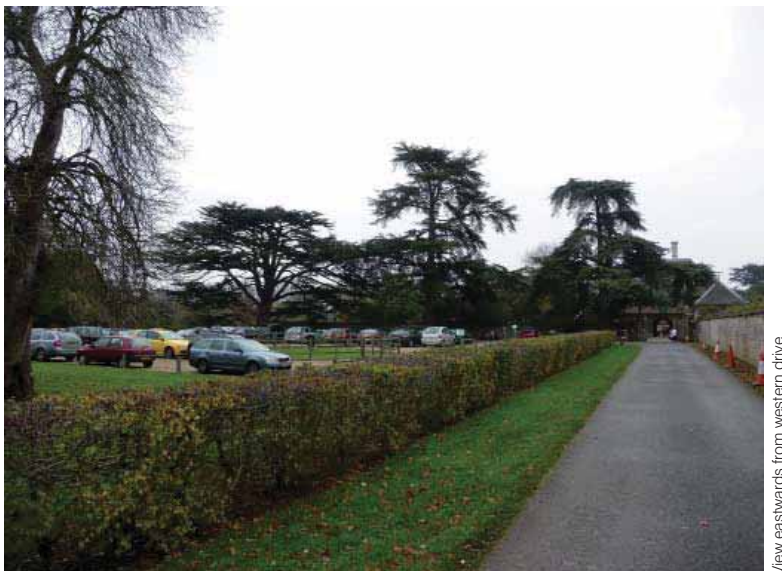
View eastwards from western drive

5.31 The public entrance to the Hall is through a pedimented arch in the garden wall and along a path (created in the 1850s) running between the garden wall to the orchard and the balustrades enclosing the western side of the forecourt which delivers you to a door within the link building. The wall to the garden is in disrepair and propped with timber shores.

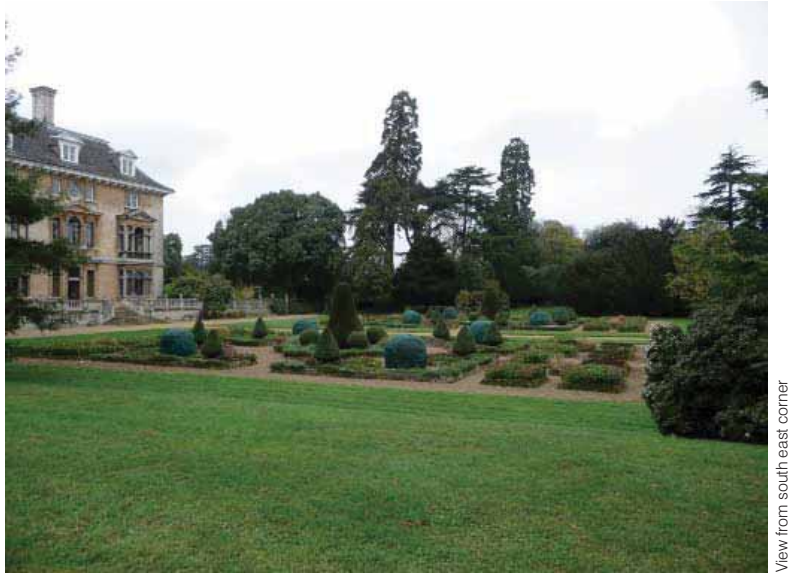
5.34 This elevation commands views over open land to the south and west, stretching towards the River Nene. A raised platform in the south-eastern corner of the gardens creates extended views back to the Hall, over the garden and out over the open former parkland. The garden walls and ornate gateway create an enclosed, formal setting to the garden and elevation, with paths on an axis to the gateway and other garden structures linking to the flight of stone steps in the centre of the elevation. The gateway is impressive, with ashlar stone piers with niches and topped with

View from south east corner

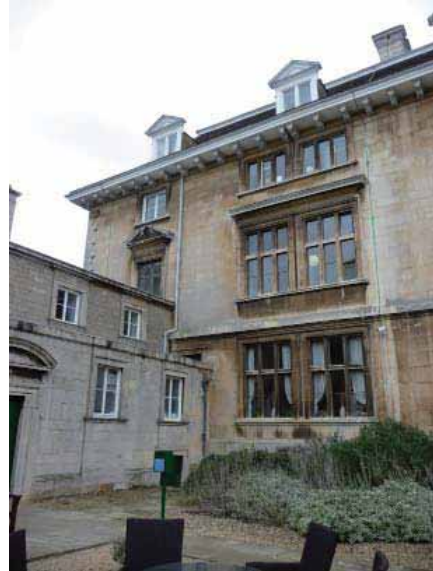
West elevation

a cornice supported on modillions. The roof has a hipped profile, with four square stone chimney shafts rising above from the central roof square.

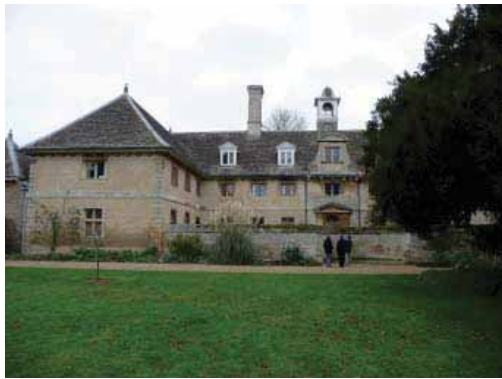
South elevation

The use of dressed stone rather than ashlar however creates a clear hierarchy between the two buildings and marks this as the service wing. Nevertheless, the building displays elements of high status and wealth appropriate for an estate of this importance. The building sits on an ashlar plinth, and an ashlar stone band wraps around the building at first floor level.

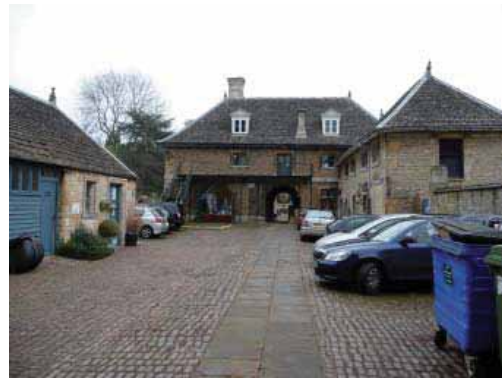
West elevation with courtyard

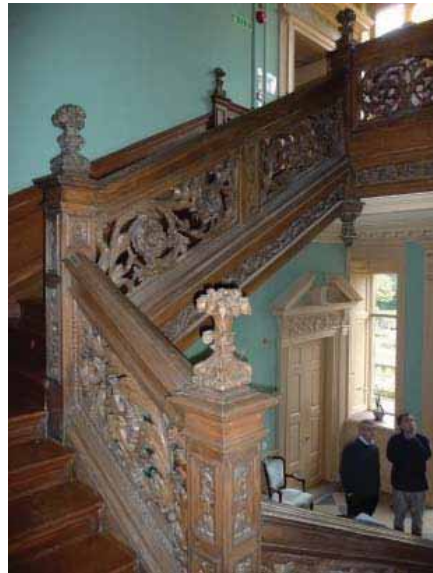
Principal staircase

5.61 The staircase of ornately carved timber showing pierced acanthus is contemporary to the construction of the house and of great aesthetic significance. In the mid-C19 an additional flight was added leading west from the second half-turn as the stair climbs, giving access to the central landing.

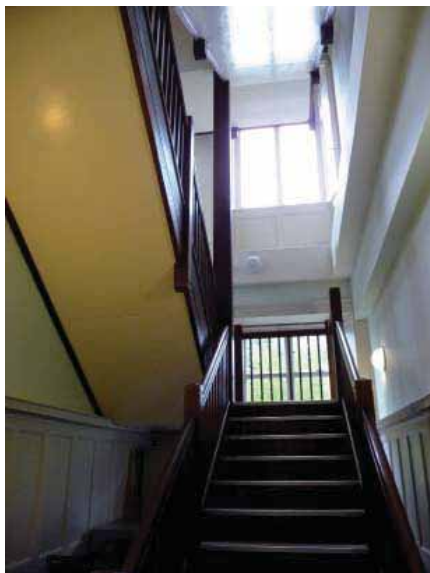
C20 staircase

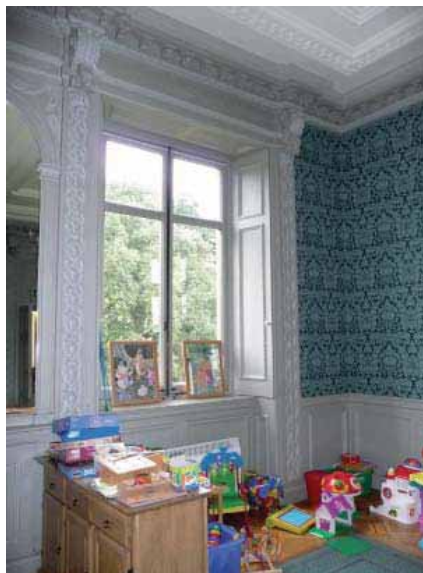
Great Chamber

5.66 The northeast room over the Hall on the ground floor was the Great Chamber [F1], commanding fine views over the east garden and beyond to distant views of Peterborough Cathedral. This is an exceptionally fine room, with decorative plasterwork to the doorcases and cornice, and high quality wainscot (the latter is not thought to be original but a later addition/replacement). The ceiling is elaborately decorated with geometric shapes and is thought to date from the end of the C18. Shutters survive to the windows, and in between each opening are large mirrors (although glass of this size cannot have formed a part of the original design). The fireplace is original and comprised of black and white marble used throughout the first floor. The parquet

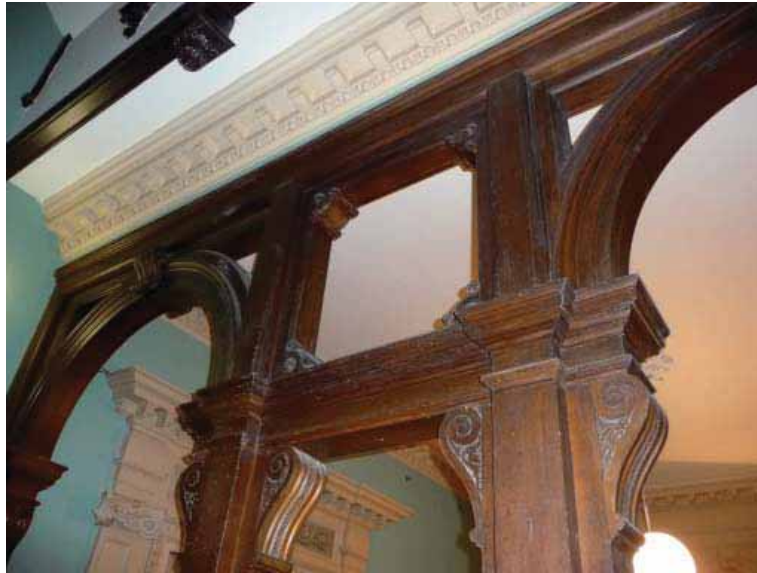
Detail of screen in western half

5.62 A back staircase behind a screen in the western half of the house was relocated from its position on the south wall to its current position on the north wall in the C19. It retains its original historic fabric however.

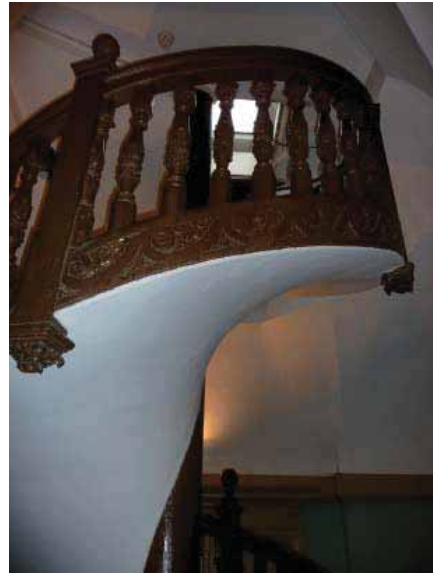
Spiral stair

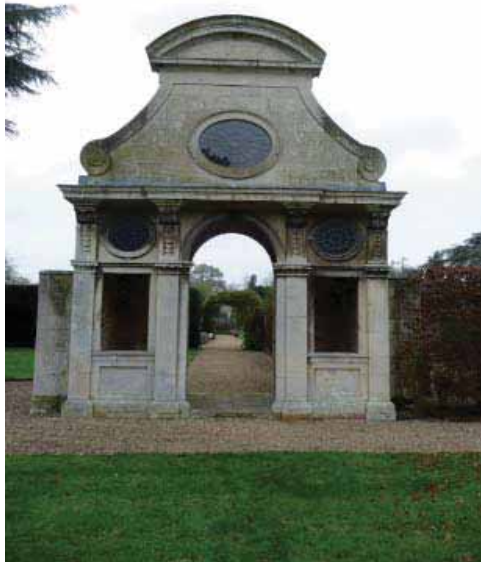
Rebuilt archway

5.91 In the south west garden, the archway from the original south wing was rebuilt in the C19 and once more stands on axis of the east-west vista. The southern boundary on the south

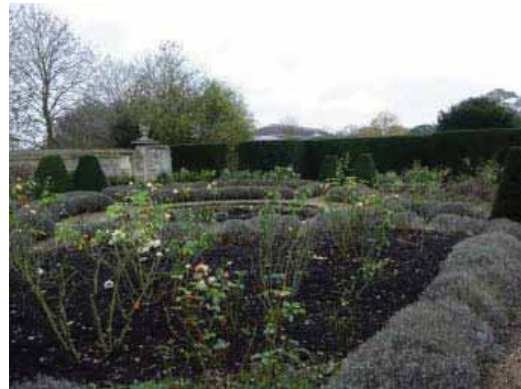
South West Garden

west side is relatively heavily planted and this serves to focus attention on the more open south elevation of the hall itself.

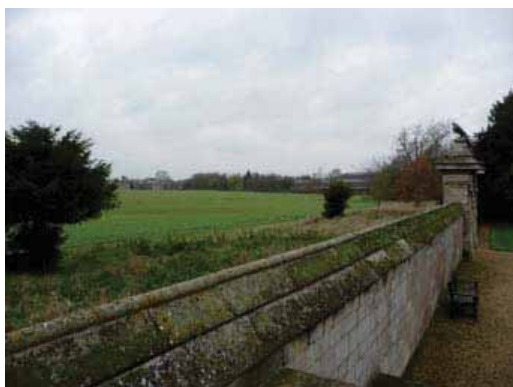
View from southern garden boundary

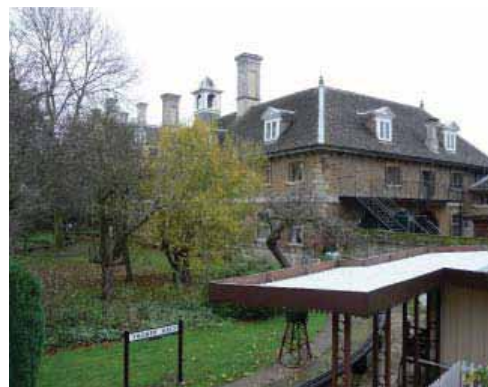
North West Garden as seen from bridge

5.98 A circular feature with low stone walls exists in the western part of the garden but it seems unlikely that this is part of the possible 'wilderness garden' shown on the earliest plans which seems to have been removed by Rev Strong. What survives in the garden are various orchard trees a mature cedar and mature, but presumably self-set, ash and horse chestnut trees. The increasing maturity of some of the trees is beginning to destabilise the walls – that to the east has been propped by raking shores for some years and that to the north is beginning to show signs of movement.

- ➡ Restoring the west gate lodge and finding an appropriate new use for the building.
- ➡ Restoring the garden walls, particularly the shored eastern wall of the north-west garden.
- ➡ Reinstating lost landscape and garden features.
- ➡ Appropriately managing the gardens and wider parkland including the surrounding drystone walls.
- ➡ Managing car parking in a way which does not intrude into the parkland setting.
- ➡ Restoring any internal features of the hall which have been subject to minor damage (eg water damage to plasterwork).
- ➡ Drawing up a medium to long-term conservation / management plan to guide maintenance issues in the Hall and gardens.
